Serial ATA Technical Errata

Errata ID	01
Affected Spec Ver.	SATAii Cables and Connectors Volume 1 Rev. 1.0 (Gold)
Corrected Spec Ver.

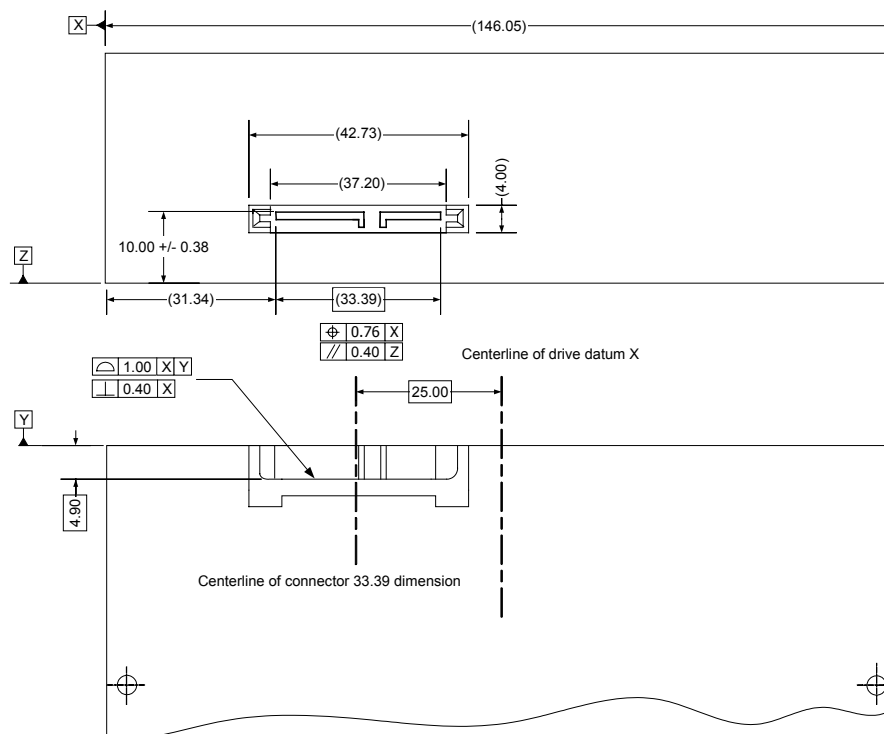
2.3. SATA connector location on the 5.25" form factor

Optical 5.25" devices need the connector location to be different than the location on smaller form factors due to differences in PCB location.

Modify the text of section 2.3 and replace Figure 2.2 with the figure shown below:

Compliant 5.25. form factor Serial ATA Devices shall have connector locations ~~and keep-out areas~~ as follows. The SATA connector is nominally flush with the I/O connector end of the device form factor.
